**INSULAR ABC 'S INITIATIVE
DEFERRED MAINTENANCE REDUCTION PROGRAM
St. Croix School District
Monday, December 7, 2015**

REQUEST FOR PROPOSAL FOR STRUCTURAL DESIGN SERVICES

**DMRP-RFP – STX-001; STRUCURAL DESIGN FOR CHARLES EMANUEL & JUANITA
GARDINE ELEMENTARY SCHOOLS**

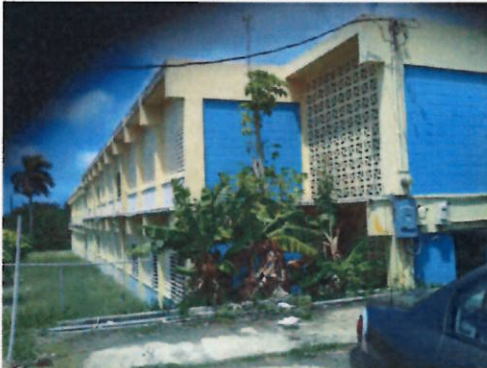
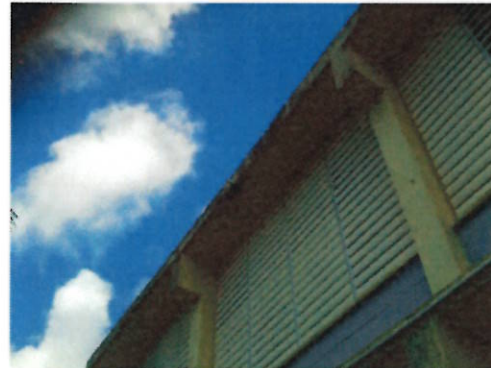
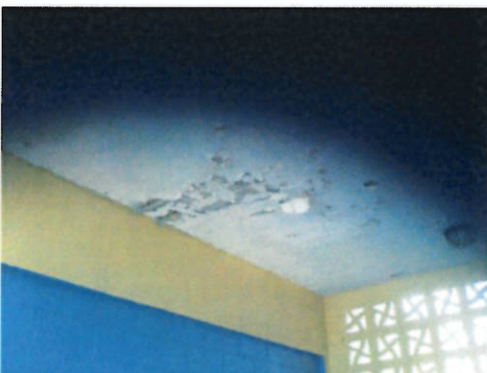
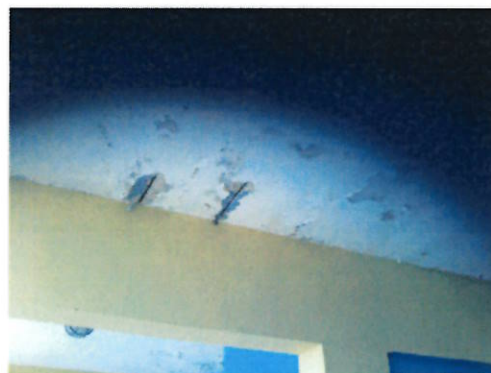
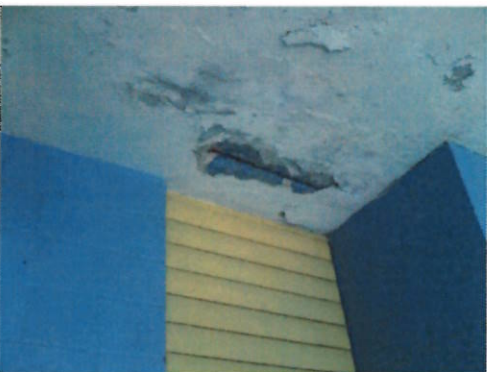
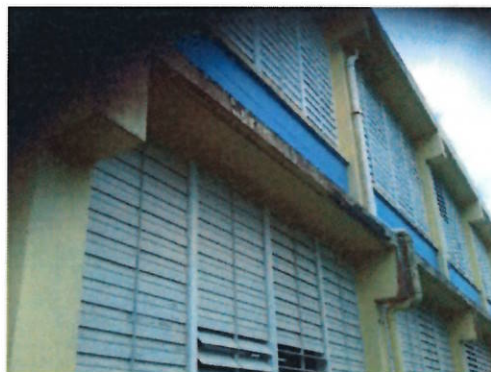
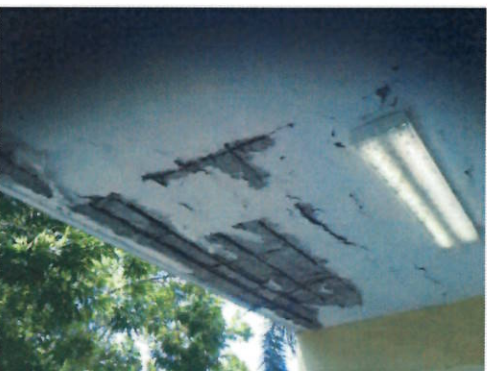
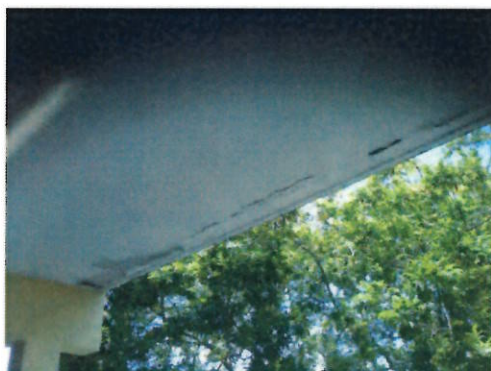
CHARLES EMANUEL ELEMENTARY SCHOOL BUILDINGS 2 AND 7

Several spalls (open and closed) were observed at the underside of the second floor and roof slab. In some cases, bottom reinforcing bars were found exposed. The largest and most extensive spalls on the underside of the slab were found in the stairwell areas. At these locations, loss of cross section at the bottom reinforcing bars was observed.

Large cracks and open/closed spalls were also observed at the edge of the slab at the second floor (awning) and roof (overhang). At the second floor, the edge spalls were located at locations typically coinciding with roof downspouts (in some cases the downspout is missing allowing rainwater to drain directly through the penetration in the roof slab and on to the second floor awning slab). At the roof, damage to the edge of the slab also coincided with the location of downspouts and overflow scuppers. All cracked and spalled concrete on the underside and edges of the second floor and roof slabs were identified as a life safety concern since they constitute a falling hazard to the building occupants.

Buildings 2 and 7 (Classroom Buildings) are two-story building framed in reinforced concrete and concrete masonry unit (CMU). The second floor and roof framing consists of reinforced concrete slabs and beams. Reinforced concrete columns carry the gravity load down to the foundation. The beams and columns create frames that are typically infilled by CMU walls at the perimeter of the building. At the second floor, the slab typically cantilevers beyond the perimeter of the building to create an awning. At the roof, the slab also creates a short overhang with an approximately 6-inch high concrete upturn/curb at the edge.

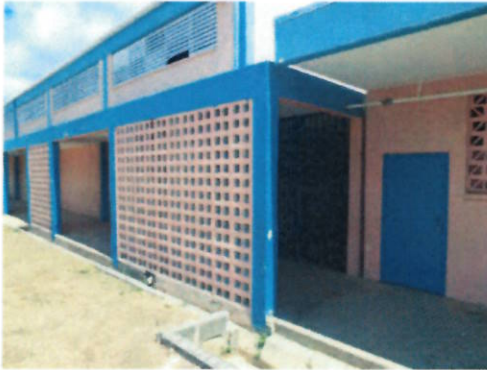
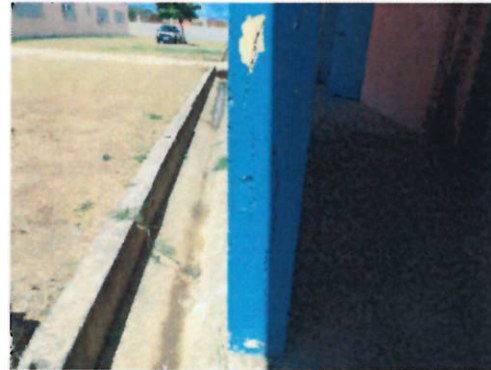
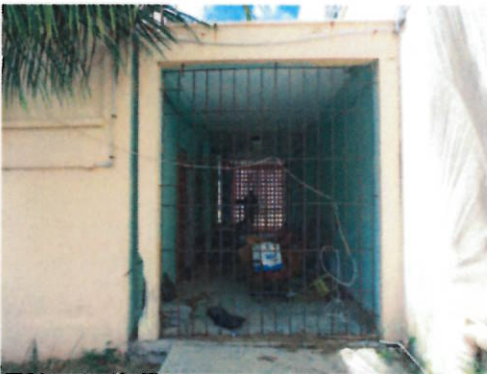
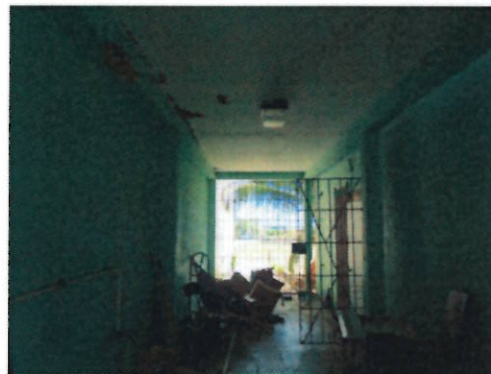
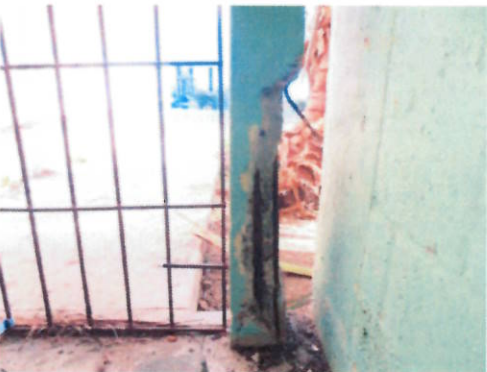
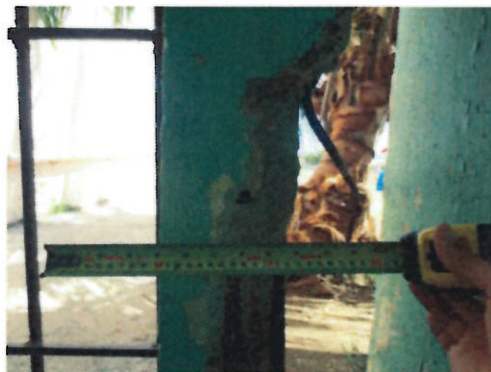
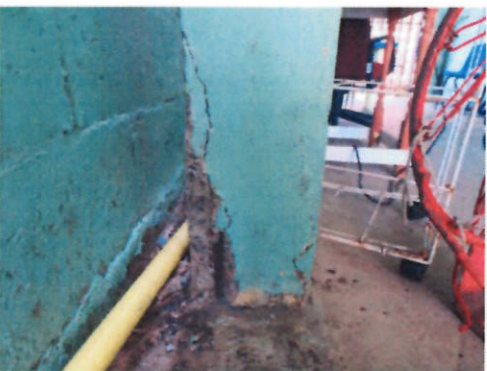
JUANITA GARDINE ELEMENARY BUILDING 12

It was observed that the walkway columns on the south side of the building have extensive cracking. No loss of cross section was observed at these columns. Miscellaneous spalls were also observed on the concrete beams at this location.

On the east side of the building, on the other hand, the concrete columns were observed to have cracked and spalled. Reinforcing was exposed at two locations and a severe loss of cross section was identified at one of the columns. Because of the severe loss of cross section and reinforcing, these columns were tagged a health and safety concern. Various cracks and spalls of different size and extent were also observed on the concrete beams and slabs within this portion of the walkway.
